REVIEW OF MINNESOTA SOARING CLUB MEMBERS FLYING ON JULY 22, 2019

CHARGE OF REVIEW

John Quilling, Manager, Stanton Airport, and George Underhill, President, Minnesota Soaring Club (MSC) charged Stephen Nesser, Chief Flight Instructor, MSC, to examine alleged violations of safe practice by pilots of the MSC that occurred on July 22, 2019.

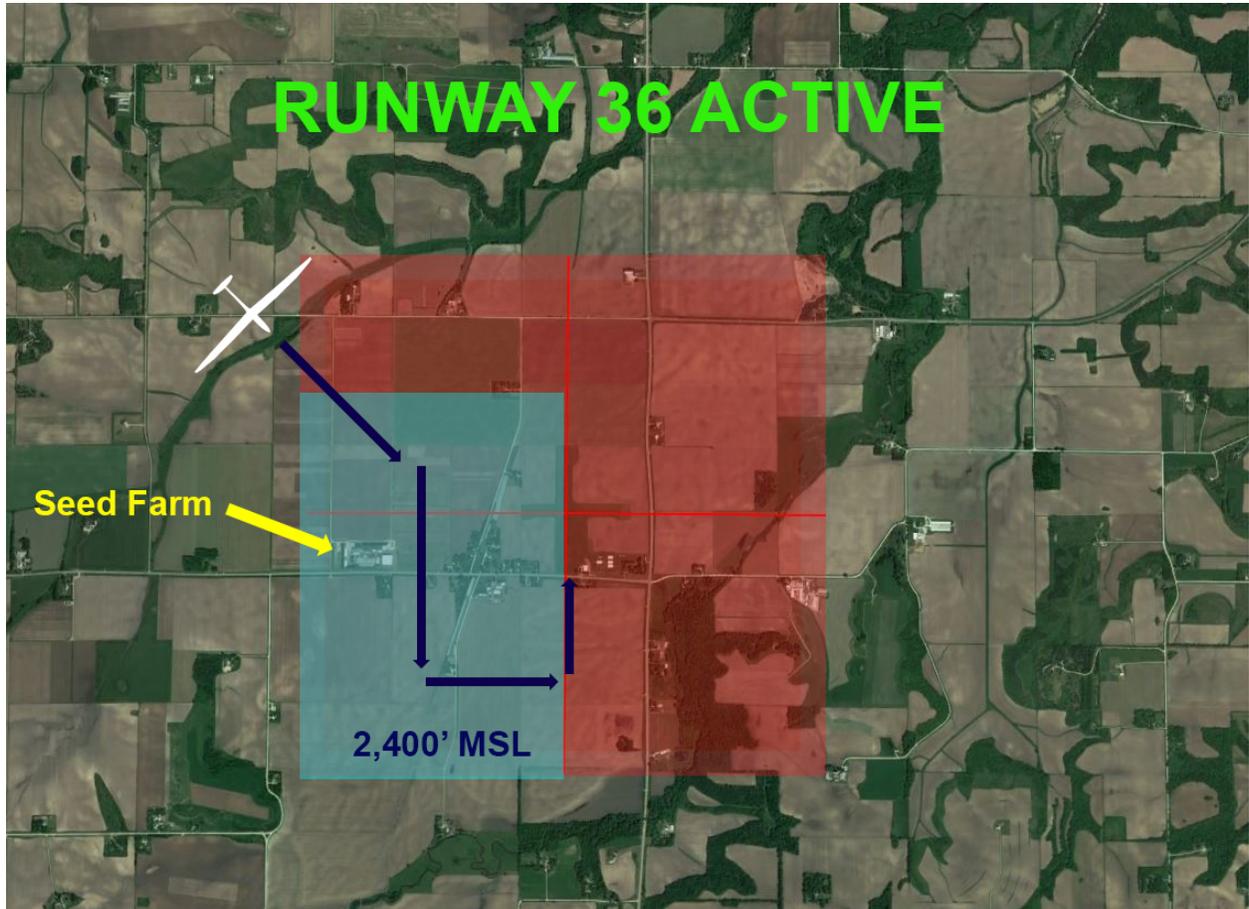
Runway 36 was active. The pattern box for when runway 36 is active is a 1.5 mile by 1 mile box that rises from the surface to 2,400 feet MSL. It is located as indicated in turquoise in Illustration 1.

Illustration 1. Pattern box for when runway 36 is active.

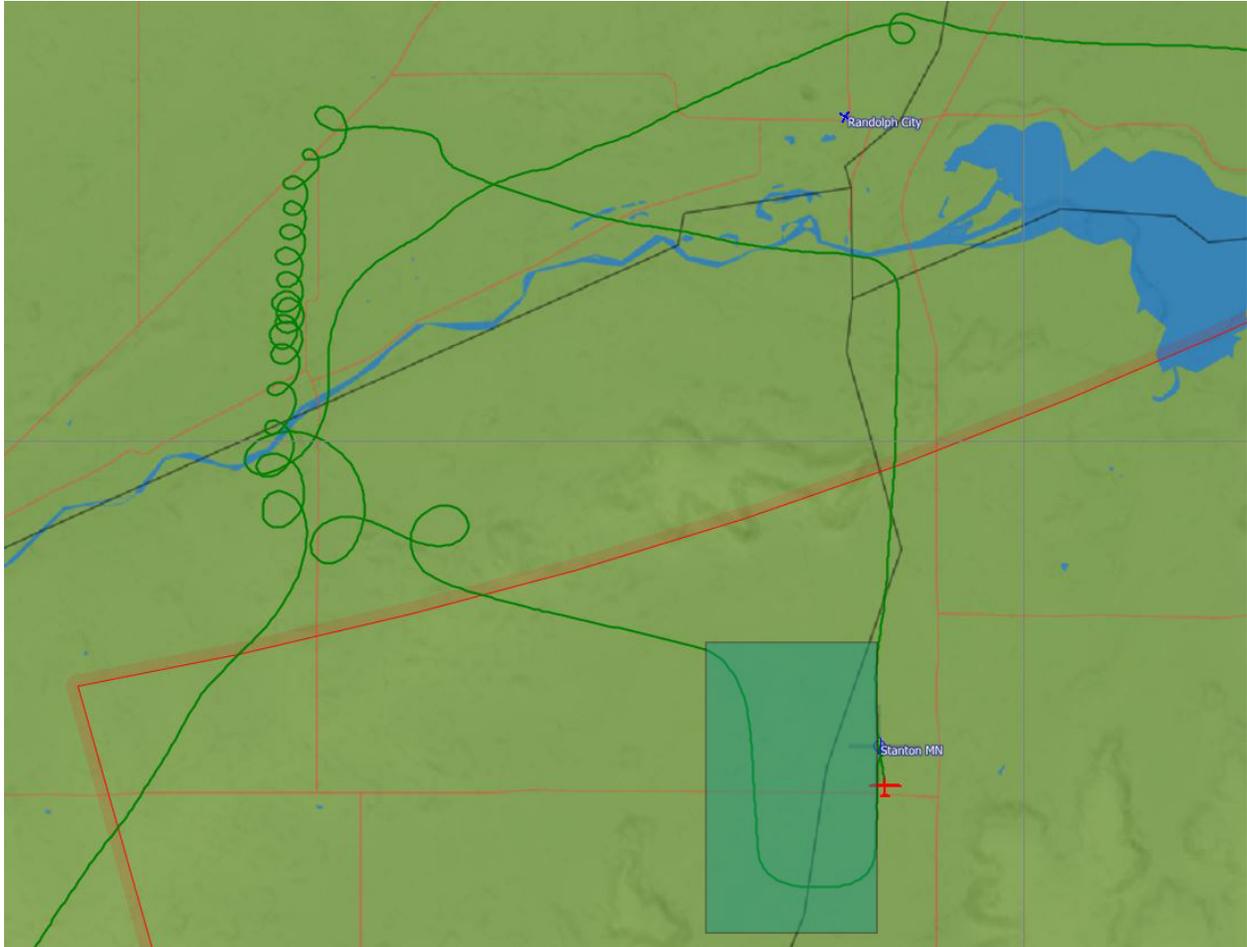
Illustration 2. Pilot 1’s IGC trace of July 22.

The distance from the northwest corner of the pattern box to the closest point of thermalling is approximately 2.3 miles based on the ruler function of Google Earth Pro. Further, Pilot 1 was flying at over 5,000 feet MSL at that time.

Pilot 1's IGC file indicates he was more than two miles from Stanton Airport when thermalling, and did not violate the pattern box.

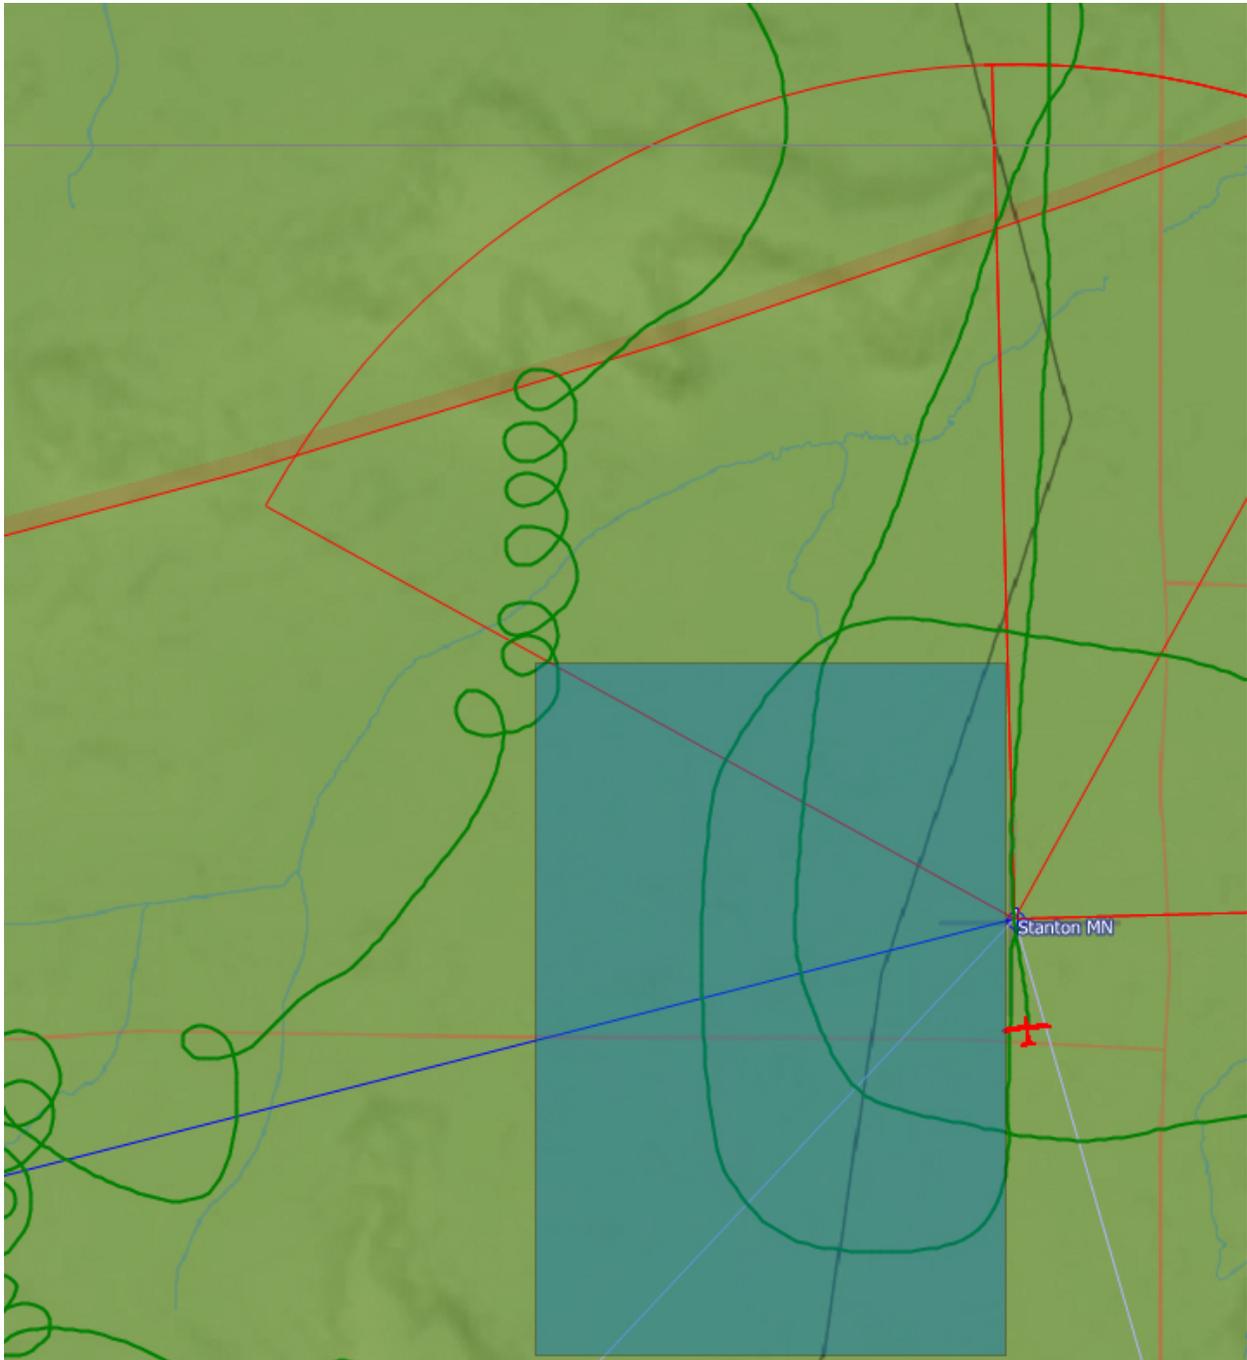
Illustration 3. Pilot 2's IGC flight trace from July 22.

Pilot 2's IGC file indicate he was laterally over the north west corner of the pattern box, but no less than 150' above the pattern box. He did not violate the pattern box. However, because he

was close to the pattern box he indicated he would redouble efforts to assure that he stayed well clear of the pattern box when thermalling.

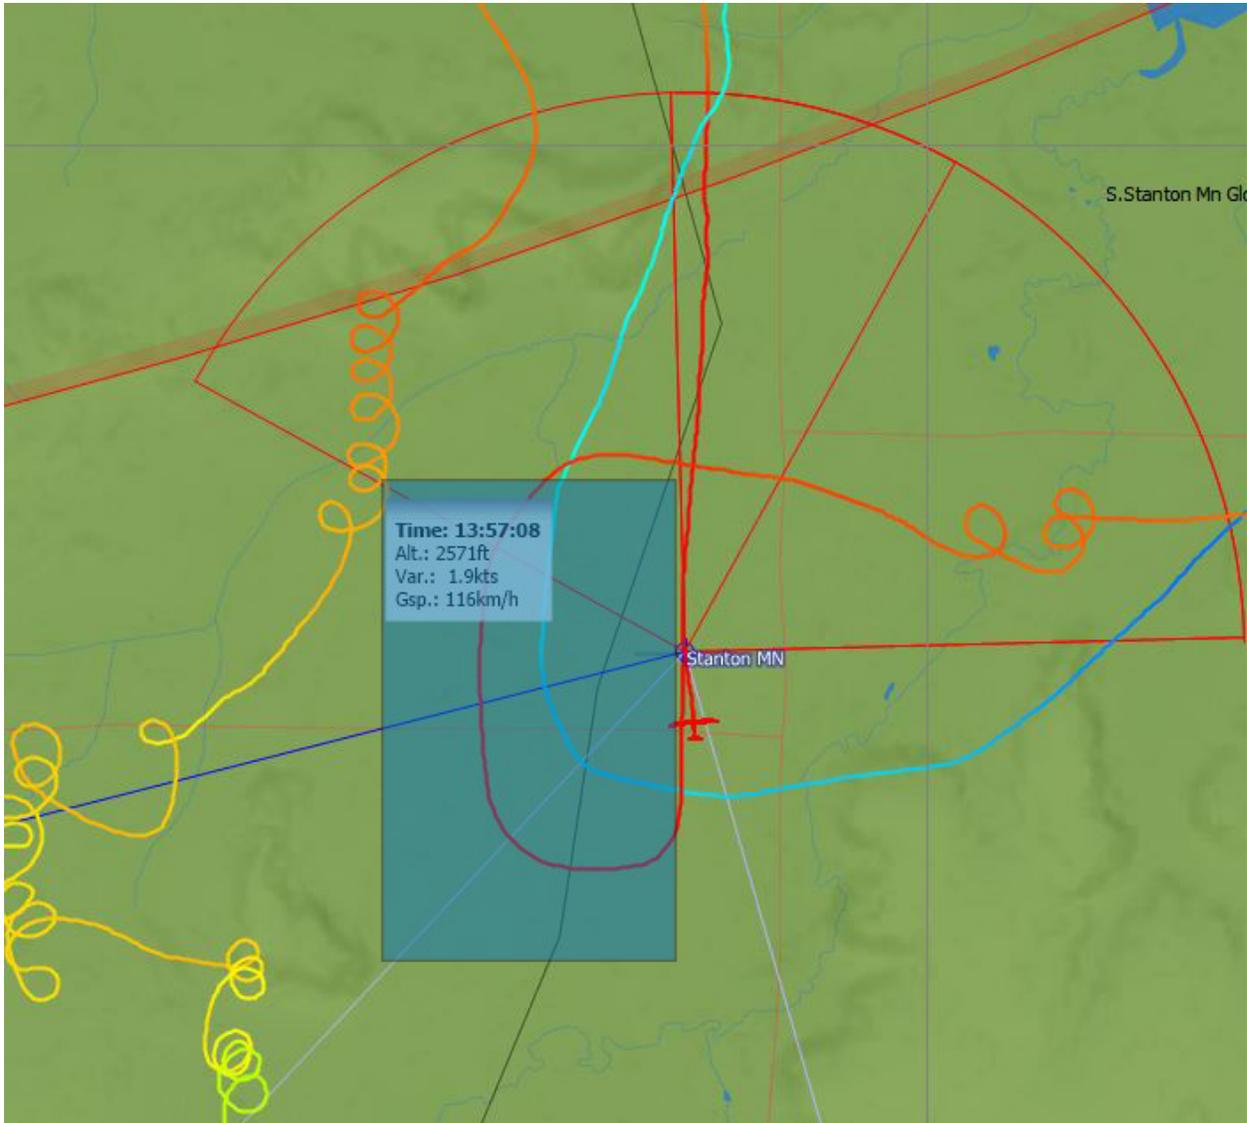
Laterally, Pilot 2 thermalled in the pattern box. Illustration 4 shows Pilot 2's altitude when laterally in the pattern box. The altitude indicated, of 2,571 feet MSL, is the lowest he was during the time he was flying laterally over the pattern box.

Illustration 4. Pilot 2's altitude.

So as to prevent any confusion about Pilot 2's flyover of the center of the pattern box, his altitude indicated by the turquoise line is more than 4,600 feet MSL.

While there were no violations of flying in the pattern box, Pilot 2 flew within 150 feet of said box—uncomfortably close. He has acknowledged this and has promised to fly with greater discretion. Accordingly, I am not recommending further action against Pilot 2 on this issue.

1. That the MSC continue to prioritize the importance of flying in the pattern box only when transitioning into the landing pattern or landing by:
 - A. Teaching all students about the boundaries of this pattern box.
 - B. Emphasizing the pattern box in flight reviews.
 - C. Restating the rules and visual limits during annual safety meetings.
2. That Stanton Airport management and MSC continue to work closely to identify and investigate all alleged violations of the pattern box and take prompt action to address any violations so that the culture of MSC be one of maximum safety.
3. That MSC pilots continue to monitor Stanton's CTAF frequency when within 5 miles of Stanton Airport, and as radio chatter allows, make periodic announcements of their position and intent when below 2,920' MSL.
