# INCIDENT REPORT: ROPE BREAK

Date of Incident: Sunday, August 23, 2020

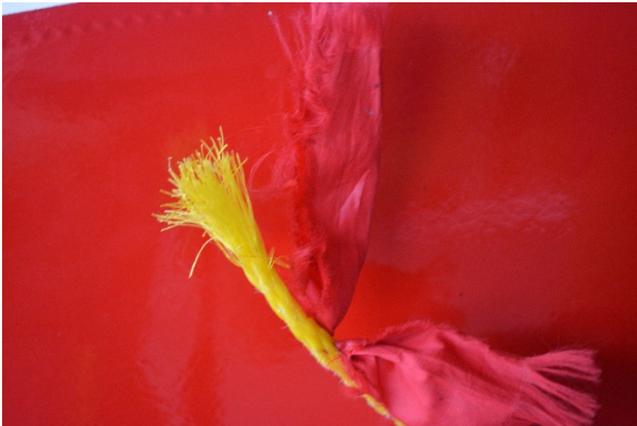
Image 1: Tow plane side of the broken rope

The Blue Ribbon Panel on Rope Breaks compared the photographs of the rope that broke on August 23 with those cut and pulled apart, and concluded that the failed rope did not break by a strong pull, but was either cut in the air or separated due to a failed splice. Committee members believe the most likely cause of the failure was a failed splice but could not rule out it was cut by rubbing against the PVC pipe.

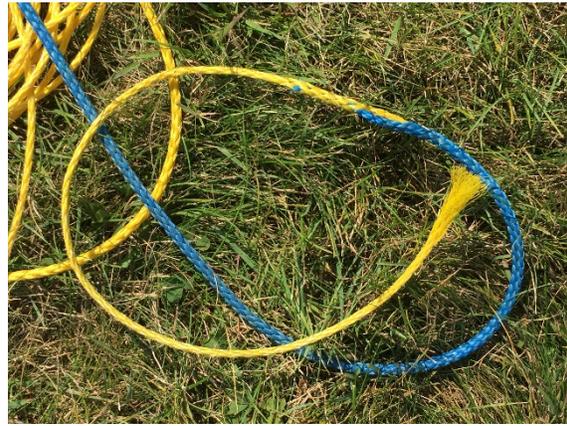
Mr. Maddux examined the failed rope and though the rope failed near the rope's exit point on the tow plane, the splice he inserted had held. His splice was under the blue sheathing in Image 2.

Image 2: Glider side of the broken rope

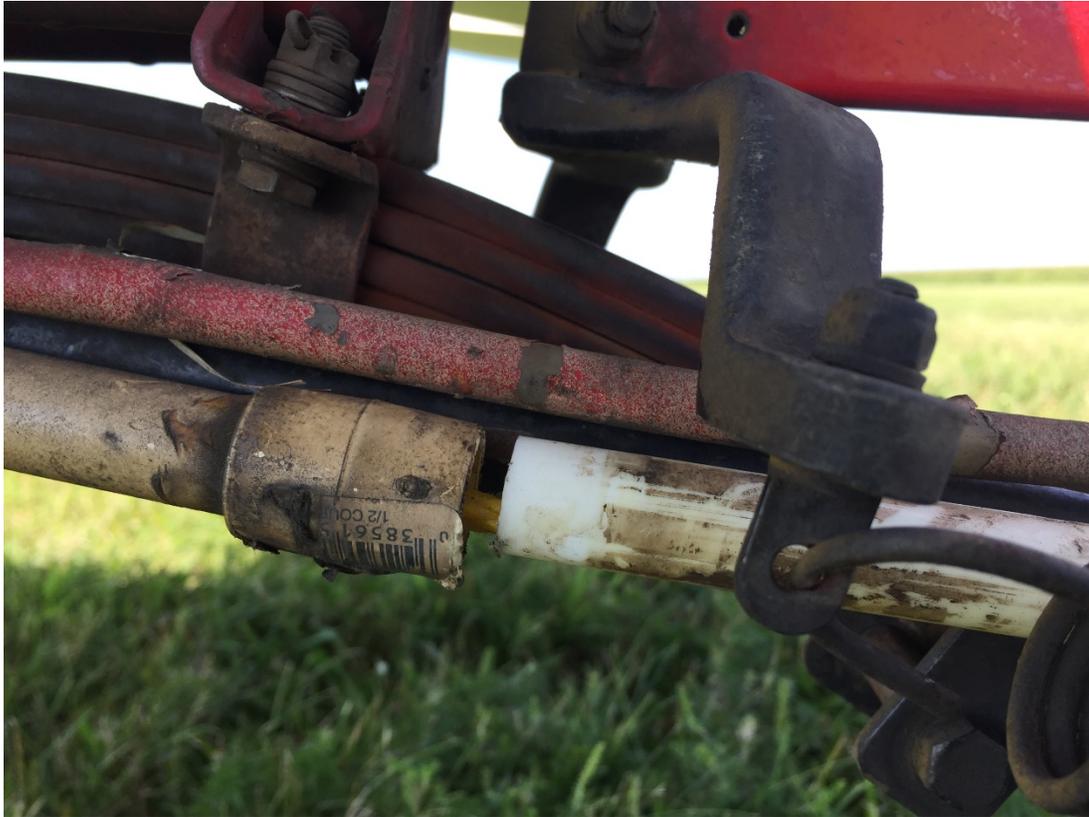
The tow plane was examined at the point where the rope failed. The tow rope runs from the winch's barrel drum through PVC tubing and out a metal horn-shaped pipe on the back of the tow plane. The last piece of PVC had separated from its PVC coupling (Image 3), resulting in the pipe sticking beyond its usual position by about one inch (Image 4).

Image 3 PVC pipe separated from coupling

MSC Director of Equipment, Mr. Biggs, believes the rope was sliced by rubbing against the PVC pipe that extended past its normal position.

1. The PVC pipe be sanded around its exit point to make it as dull as possible and be glued (at the coupling) pulling the end into its normal recessed position. (Completed on August 24, 2020)
2. A new rope be installed on MSC's Super Cub (Completed on August 24, 2020)
3. All eye splices of the tow rope be completed as illustrated below:

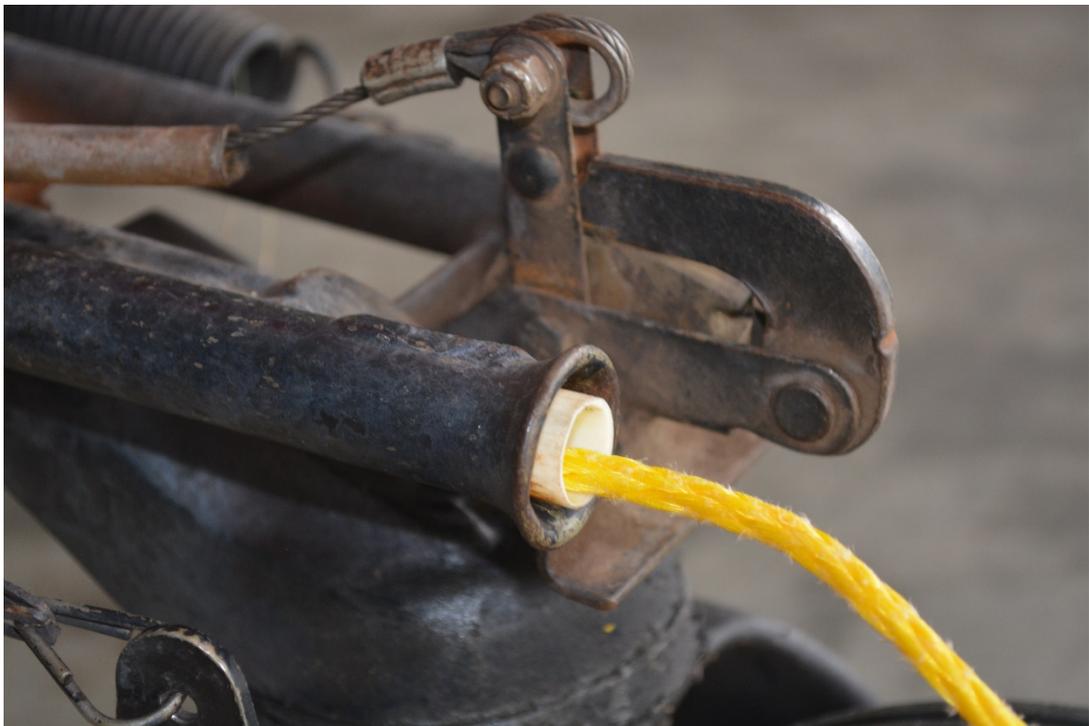
Image 4 The PVC pipe sticking out of the exit point at the end of the tow plane

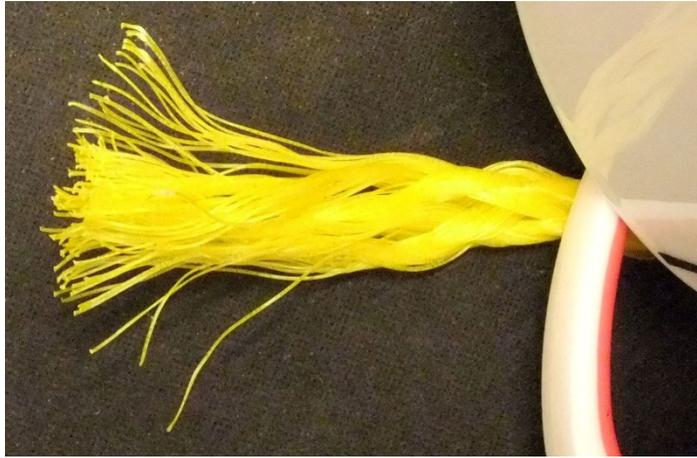
Image 5 Rope cut with scissors

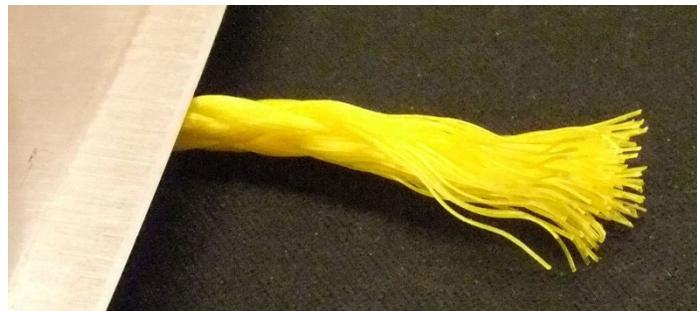
Image 6 Rope cut with a knife

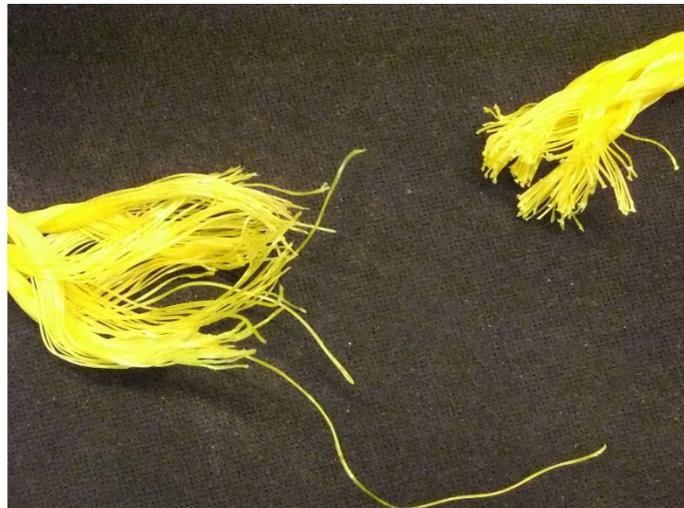
Image 7 Rope pulled apart by force
