INCIDENT REPORT: NEAR MIDAIR COLLISION IN TURN TO BASE

Date of Incident: September 23, 2020

Stephen Nesser, CFI-G
Chief Flight Instructor
Minnesota Soaring Club

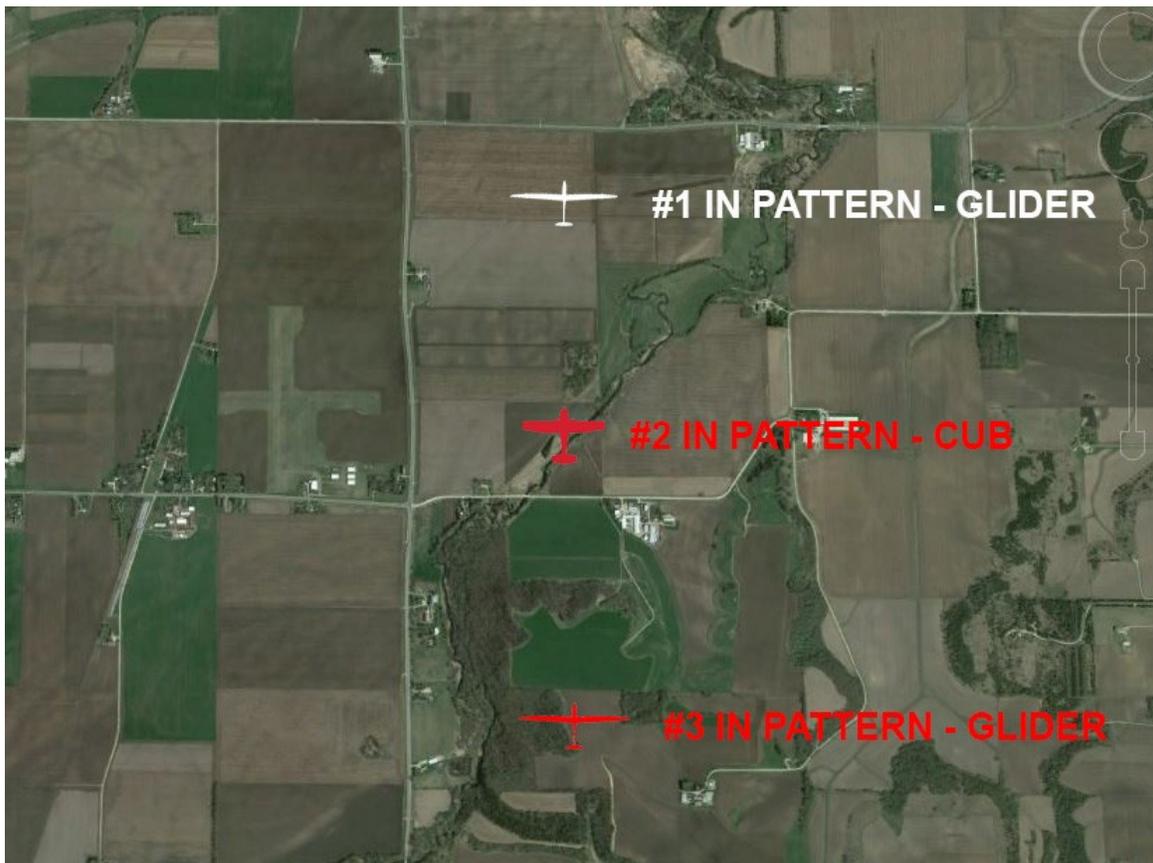
Illustration 1

The Pilot reports returning to the southeast area of the airport with ample altitude after a 150-minute glider flight and using the extra altitude, and the time that it provided, to monitor Stanton Airfield's airspace and radio transmissions. Radio calls and scanning showed an active pattern and accordingly the Pilot entered the pattern on a high and long 45 dog leg, making a radio call on the common traffic advisory frequency 123.3, and losing altitude with airbrakes. The Pilot turned to downwind at 1,700' MSL and announced position on the radio on. The Pilot was number three in the traffic pattern. The first aircraft in the pattern was a glider and the second a Piper Cub. Each aircraft was spaced a half-mile from the other as shown in Illustration 1.

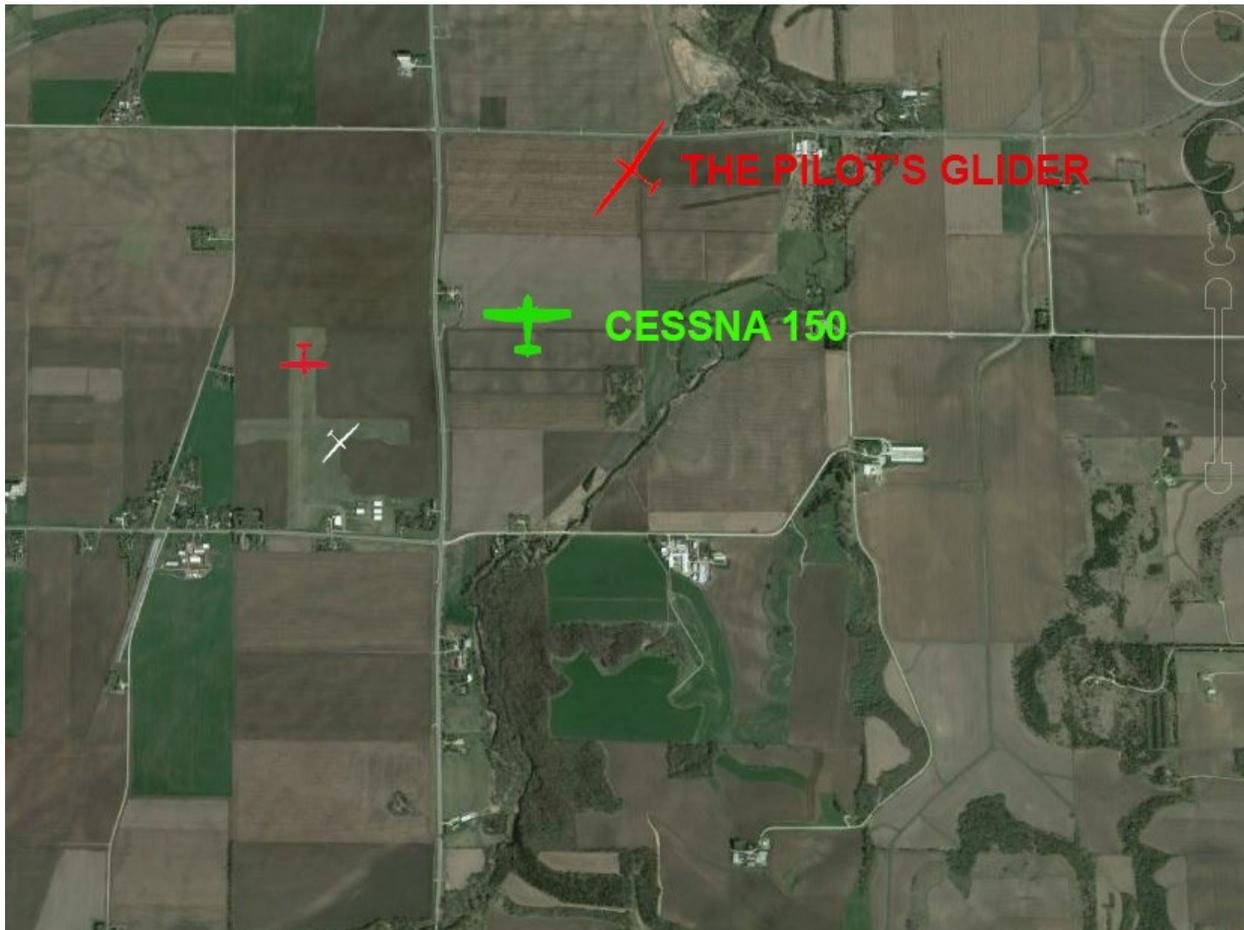
Following the other two landing craft (that I was aware of) and with which I had visual contact, I made my base turn to the west, rolled out of the turn, and seconds later a green C150 appeared at my same altitude, running northbound.

Illustration 2 The position of the four aircraft as the Pilot turned to base.

I had about 2 seconds to consider the situation and about five more seconds to possible impact, so elected to immediately descend below the C150 and pushed my nose down. I also retracted my flaps because they have an 86 kt maximum extension limit, and went under the C150 by 50'-75'.

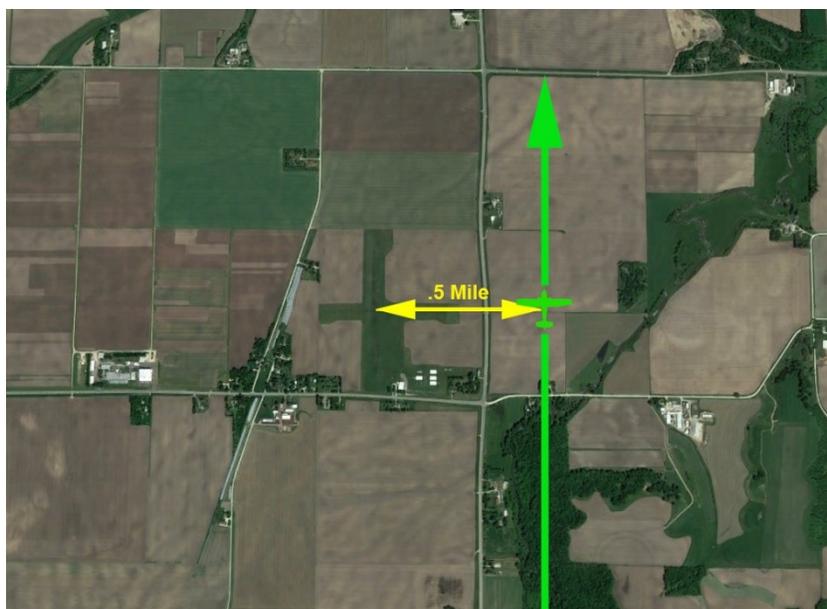
Mr. Lindenfelser stated that he trains students to fly the downwind wider and longer than gliders typically fly, but never so long or wide that the C-150 could not reach the airport for a safe landing should the engine fail. This results in the downwind leg positioned about a half-mile from the runway's centerline as show in Illustration 3.

Illustration 3 Half mile from the centerline on Runway 18.

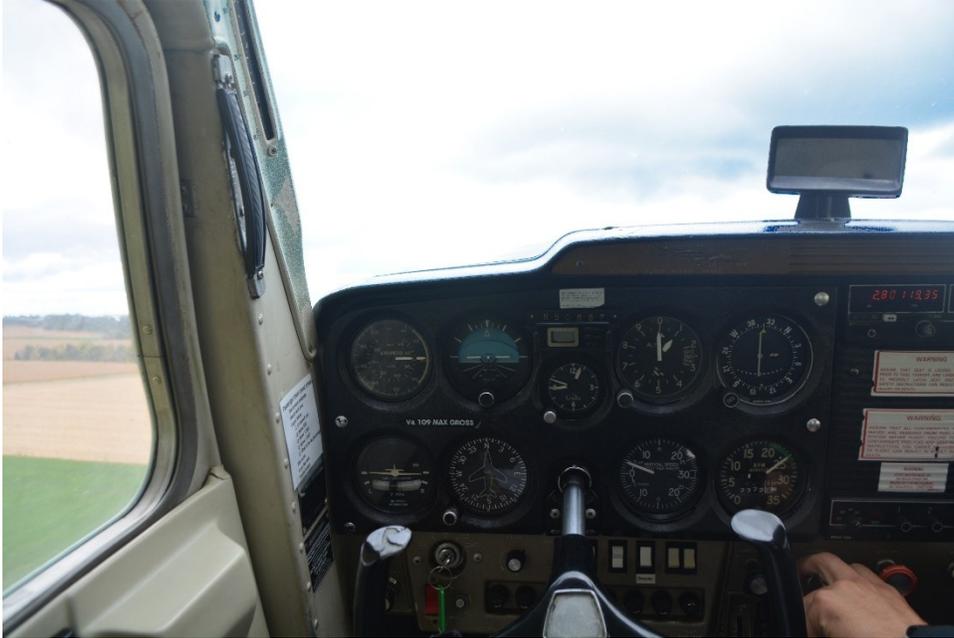
Airplane pilots are trained to enter the pattern at 1,920' MSL and maintain that altitude until abeam the cross runway the pull power back to feathered. Pattern airspeed on downwind is generally 80 to 85 MPH (70 to 74 knots); base 70 MPH (61 knots), and final 60 MPH (52 knots). At 80 MPH a pilot's view ahead and below from the C-150 is limited ahead and below.

Illustration 4 View from pilot's seat of a C-150 at 80 MPH

Airplanes usually enter the pattern 200 feet higher than gliders, positioning gliders beneath the airplane. As Illustrations 4, 5 and 6, illuminate, much of the airspace ahead and below a C-150 pilot is obstructed. These photographs show the line of sight of a shorter pilot, and view increases with taller pilots. Given that a glider pilot will typically lose altitude throughout all phases of the pattern, and an airplane pilot will maintain their altitude until reaching the cross runways, this obstructed view is likely to increase in the first part of the downwind. Therefore, it is wise to assume, in all aspects of flight but especially in the pattern, that a glider is invisible to airplane pilots (and not infrequently to other glider pilots).

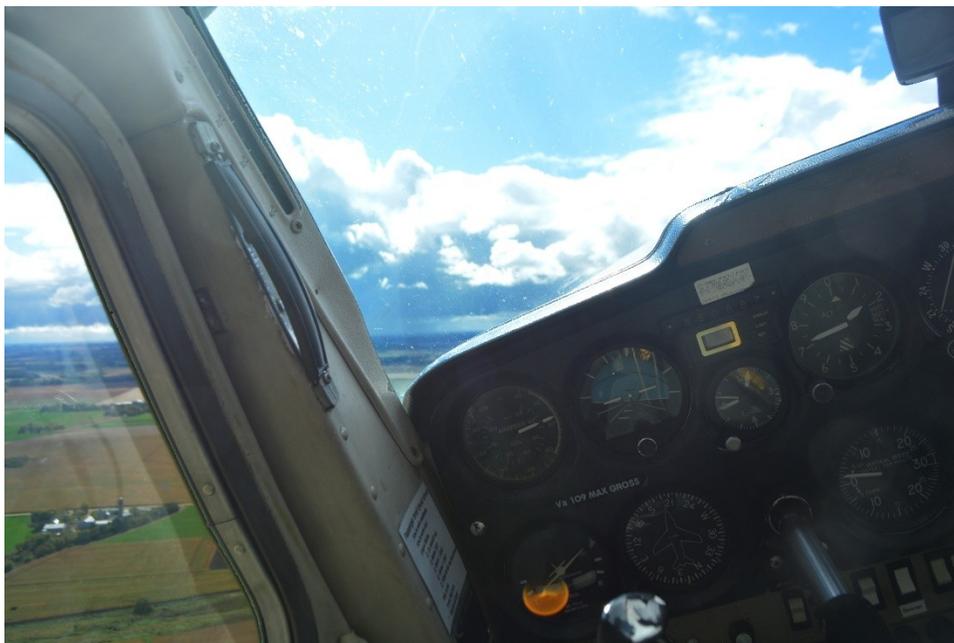
The pilot's view ahead and below remains limited in a turn as shown in Illustration 4.

Illustration 5 View from pilot's seat in a 75 MPH turn in the C-150.

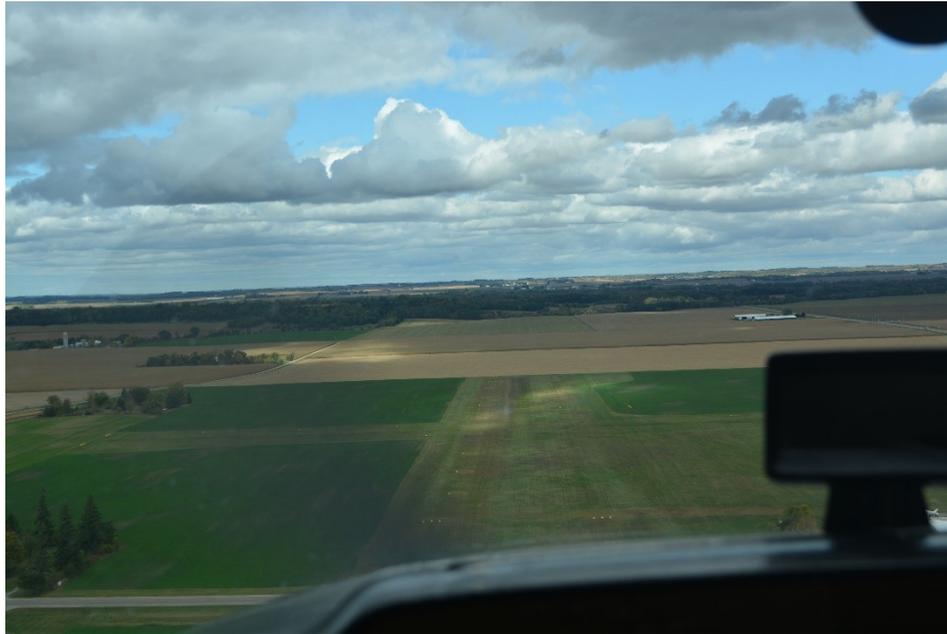
The pilot's view below and ahead improves on final approach.

Illustration 6 View from pilot's seat at 60 MPH on final approach.

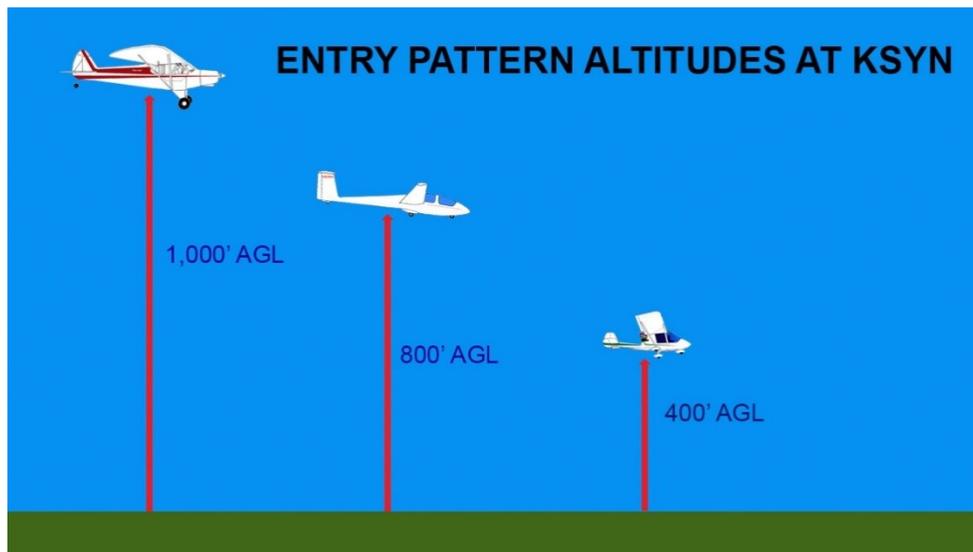
The *Airport/Facility Directory* gives three pattern-entry altitudes for Stanton Airfield: 1,000' AGL for airplanes; 800' AGL for gliders; and 400' AGL for ultralights (Illustration 7).

Illustration 7 Altitudes to enter the pattern at Stanton Airfield.
