INCIDENT REPORT: NEAR MISS IN A THERMAL

Date of Incident: June 9, 2023

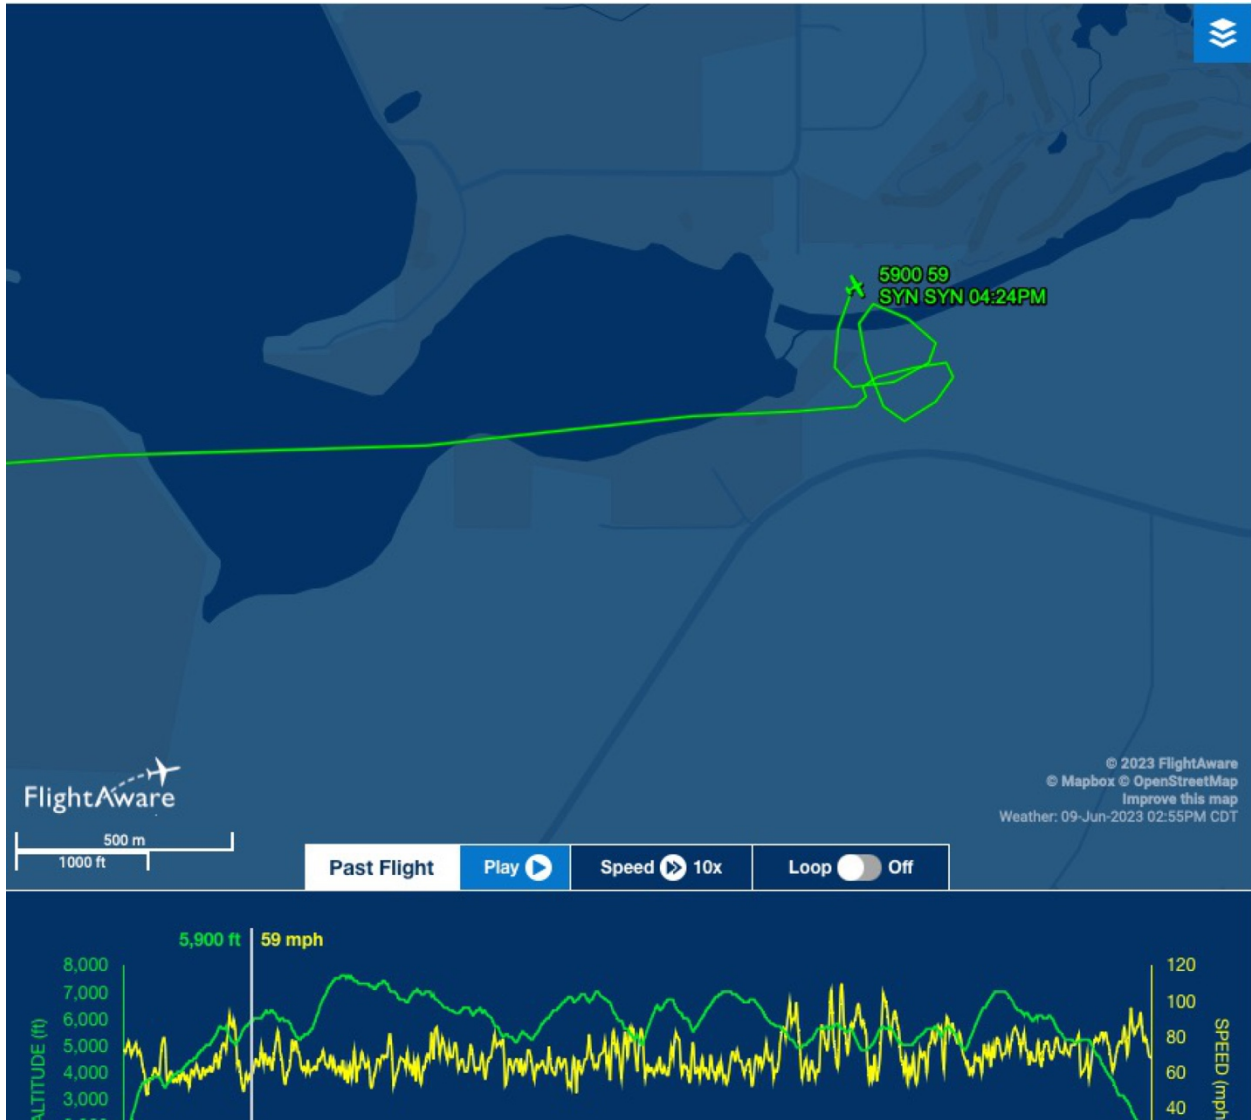
Pilot 1's flight trace during the period the near miss occurred.

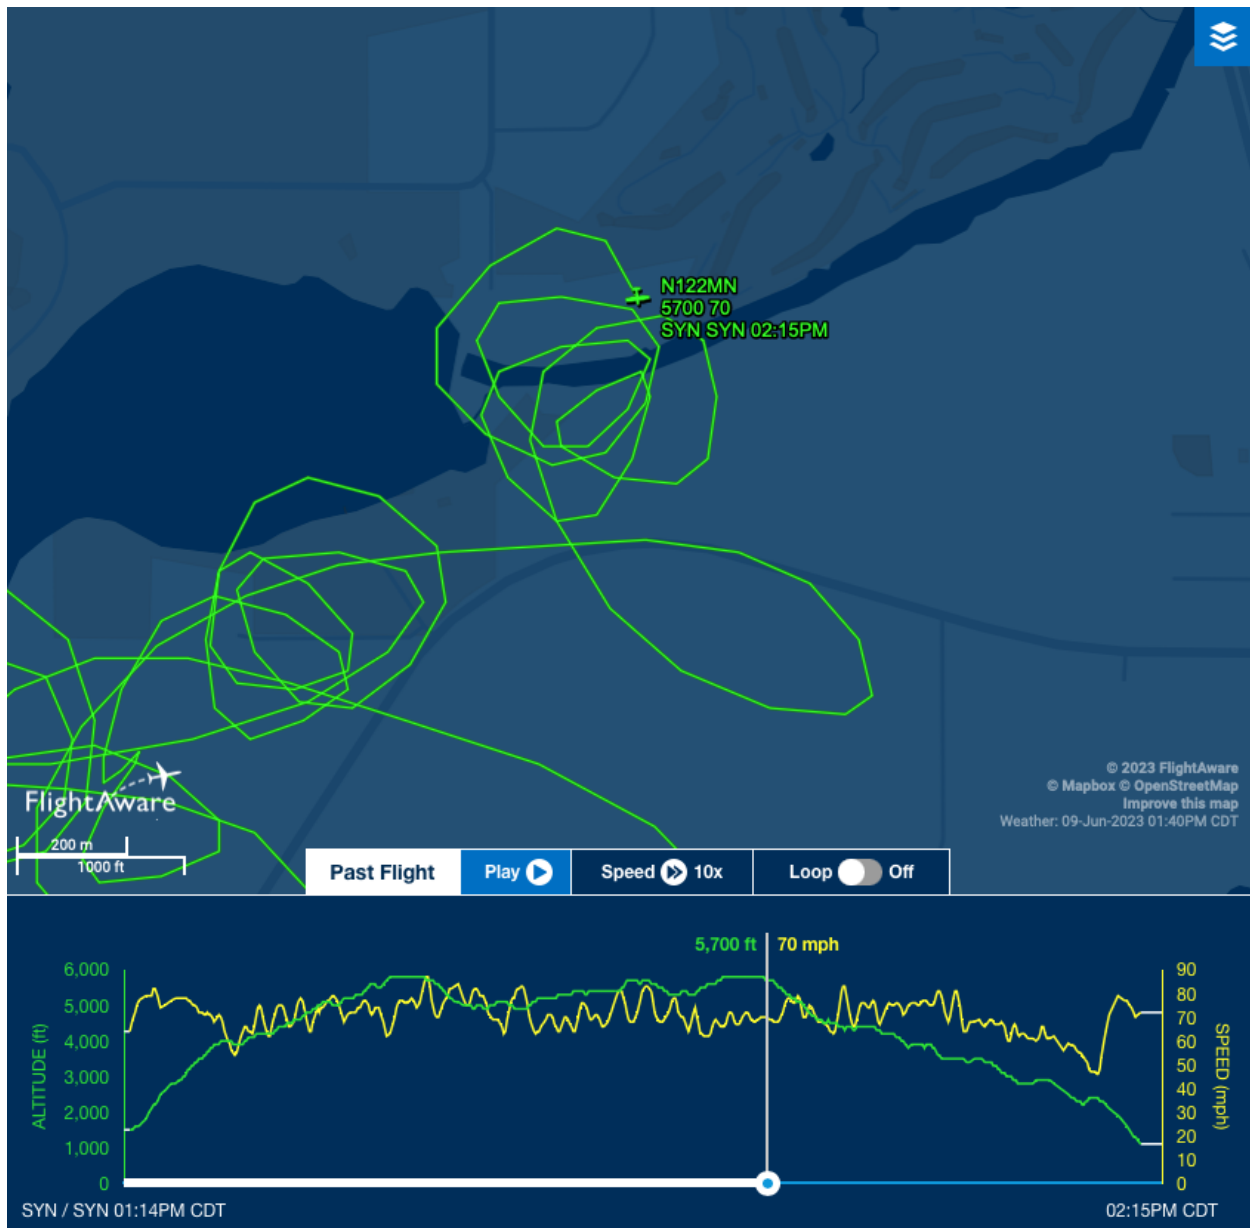
Pilot 2’s flight trace during the period when the near miss occurred.

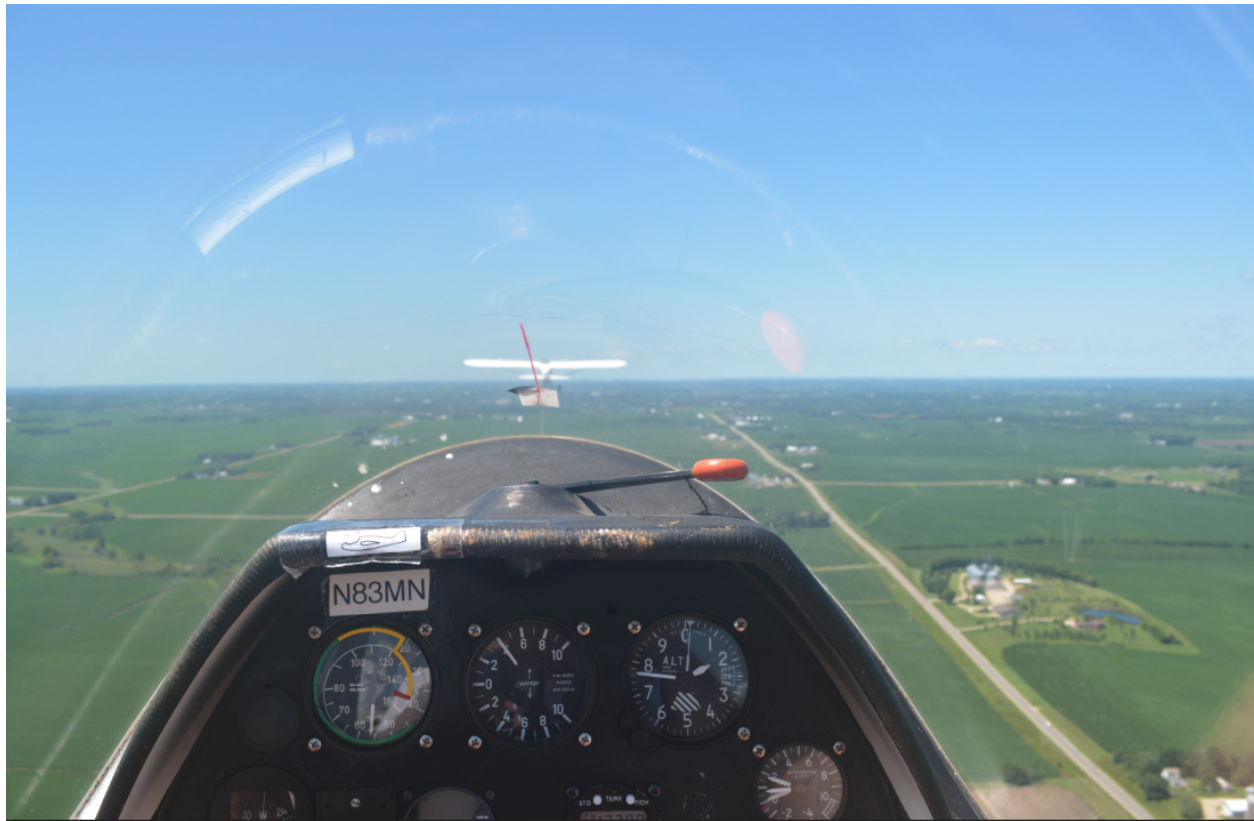
There are structures in every glider that obscure a pilot’s vision. For example, the floor, instrument panel, and forward portion of the glider obscure the airspace ahead-and-below the pilot. That means, that the area into which the glider is flying in still or sinking air is likely obscured in straight and level flight.

View from the pilot's seat. Note what can't be seen.

It is possible, perhaps likely, that Pilot 2 failed to see the private glider when it was 100 feet below him because it was beneath the ASK 21 B's instrument panel and fuselage.

1. Pilots remind themselves of the structures in any glider they fly that obscures their lookout.
2. Pilots flying straight and level in still or sinking air make occasional mild banks or yaw to see the area ahead and below their flight path.
3. Pilots keep a mental map of all aircraft flying in their vicinity.
4. Pilots thermalling near each other maintain radio contact on frequency 123.30.
5. The Minnesota Soaring Club strongly consider installing an ADS-B In system in the club gliders.

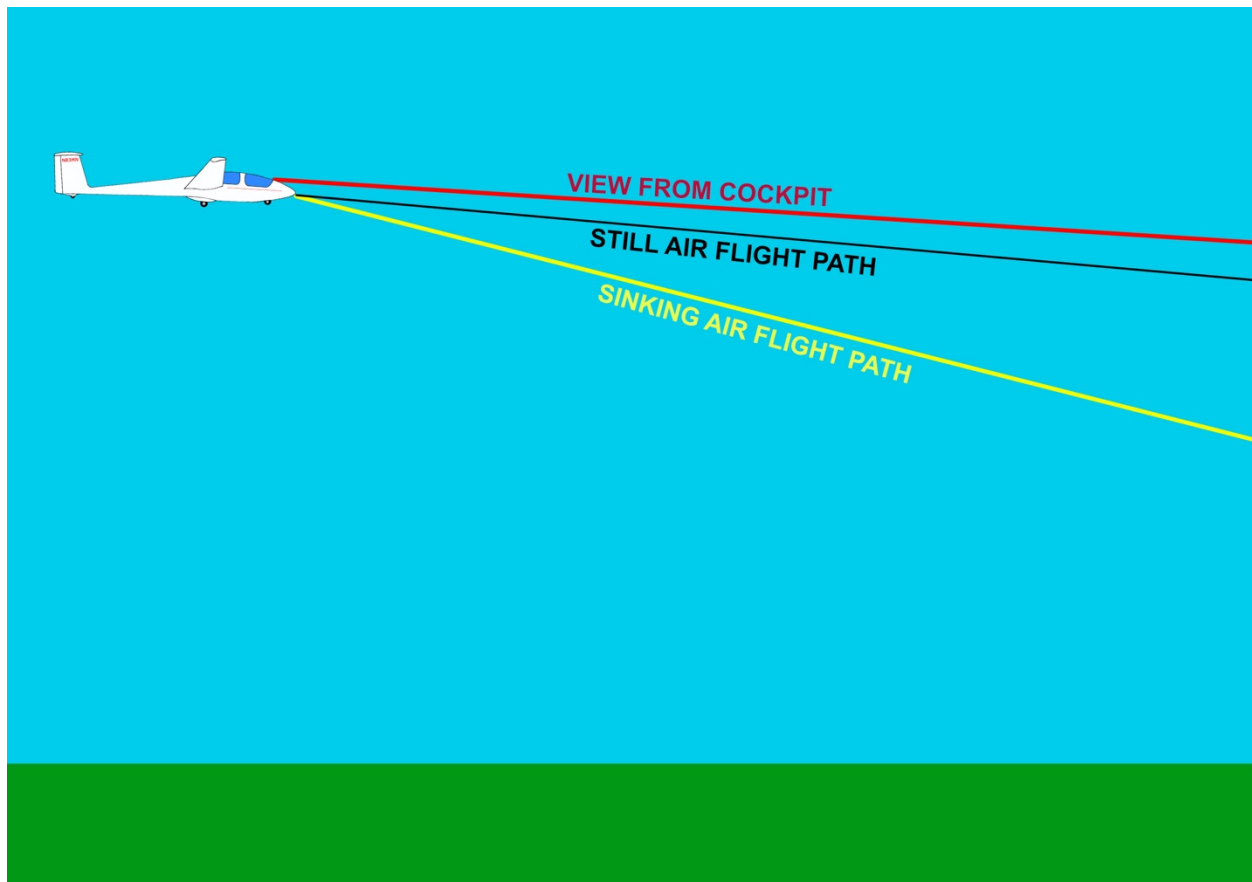
When the nose is dropped for increased airspeed, the pilot sees further ahead, but simultaneously increases the sink rate.

Comparison of sink rate versus limits of cockpit view.
